Aviation Investigation Preliminary Report

Location: Anderson, IN Accident Number: CEN24FA340

Date & Time:September 6, 2024, 09:48 LocalRegistration:N629AG

Aircraft: PIPER AIRCRAFT INC PA 46-350P Injuries: 4 Fatal

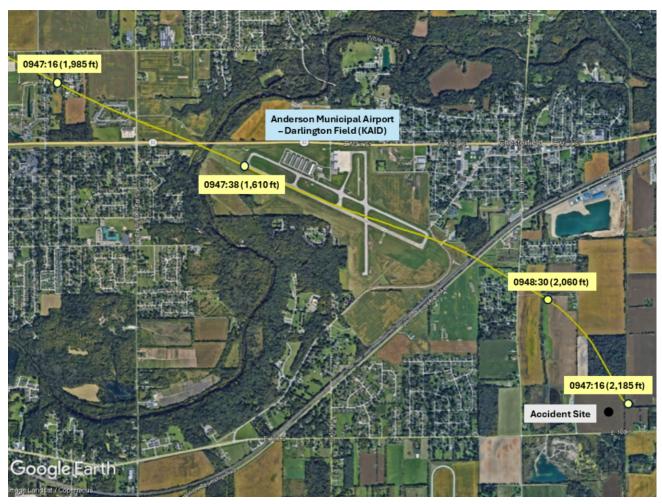
Figure 1 - Final Segment of Airplane Flight Path

About 0947:16, when the flight was 0.9 miles west of the runway and about 1,985 ft msl, the pilot informed the controller he needed to go around. The controller subsequently cancelled the approach clearance and instructed the pilot to turn right to a heading of 180° and climb to 3,000 ft msl. The airplane continued toward the airport, and at 0947:38, crossed the runway 12 threshold about 1,610 ft msl [730 ft above ground level (agl)]. The airplane flight track drifted slightly north-northeast of the runway centerline. About 0948:30, the airplane appeared to start a gradual right turn. At that time, the airplane was about 0.60 miles southeast of the departure end of runway 12 at an altitude of about 2,060 ft msl. The final ADS-B data point was recorded at 0948:55 with an associated altitude of 2,185 ft msl (1,349 feet agl).

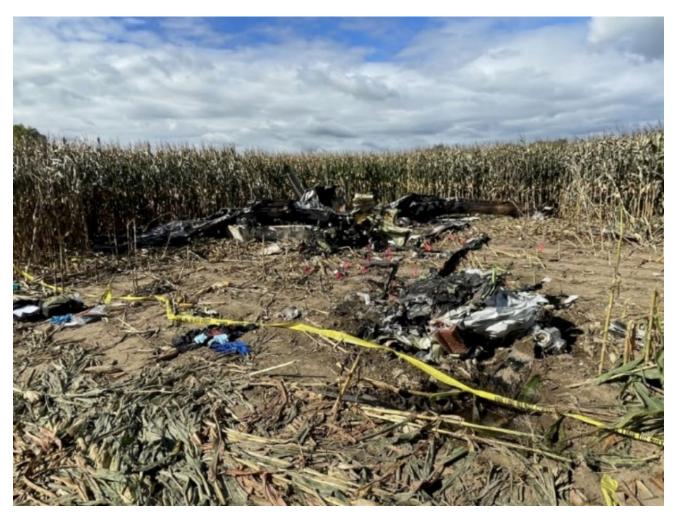
Figure 2 - Airplane Wreckage at Accident Site

The accident site was located in a corn field about 1 mile southeast of the departure end of runway 12 at an elevation of 923 ft. This was about 547 ft southwest from the final ADS-B data point. The airplane came to rest upright on a northeast heading. The debris area extended about 50 ft southwest from the initial impact. The airframe was fragmented, and portions were consumed by a postimpact fire. The engine and forward fuselage were located adjacent to a 4-foot diameter impact crater. All three propeller blades were separated at the blade roots and positioned near the crater. The cockpit area was located about 12 feet from the forward

fuselage. The wings and center fuselage were positioned about 15 feet from the cockpit debris. The aft fuselage and empennage were located in position adjacent to the wings. Both main landing gear struts were in the extended position; the nose landing gear was separated.

Major airframe structural components were located at the accident site. Portions of the airframe were consumed by the postimpact fire. Each flight control surface, including both wing flaps, either remained attached to the airframe or was separated and located within the debris path. The wing flap actuator was not observed and the flap position at the time of the accident could not be determined. However, based on the examination of the available wreckage, no evidence of an inflight structural failure was observed. The airplane was retained by the NTSB for further examination.
